Taylor Pond Watershed Survey Report

June 2023

Prepared for:
Taylor Pond Association
585 Garfield Rd
Auburn, ME 04210
www.taylorpond.org

Prepared By:
Androscoggin Valley Soil & Water Conservation District
254 Goddard Road,
Lewiston, ME 04240
www.androscogginswcd.org

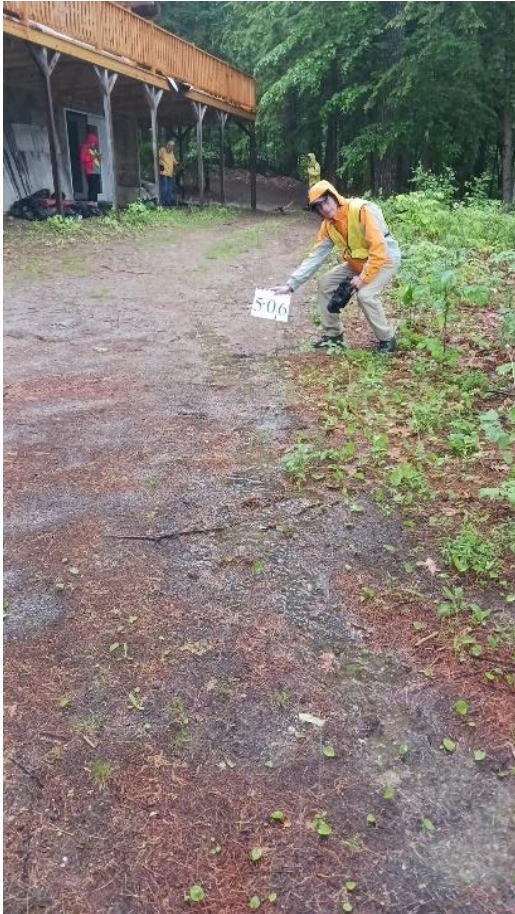
Figure 8: Example of surface erosion identified on a residential site.

Survey team recommendation to install check dam(s) to slow water flow so it can infiltrate before it reaches the pond.

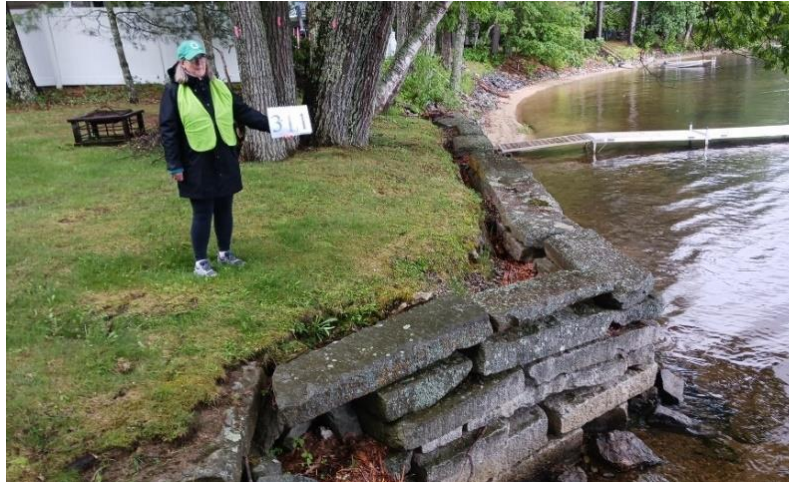
Figure 9: More dramatic erosion identified on a residential site.

Runoff is eroding the shoreline behind retaining wall is eroding, causing other problems.

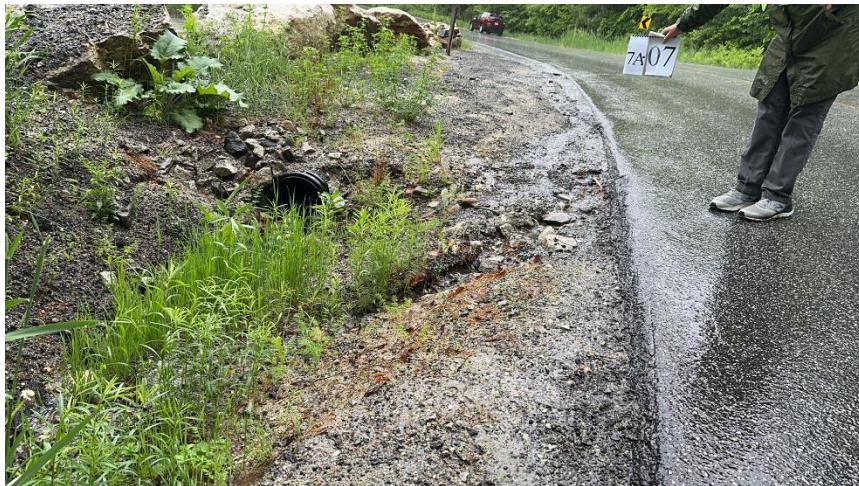
Figure 11: A high-impact town road

Gully forming and eroding road shoulder on Harris Road. Culvert is perched and too small. Survey team recommends replacing and enlarging the culvert, installing check dams in the ditch, vegetate shoulder, and armor culvert with stone.

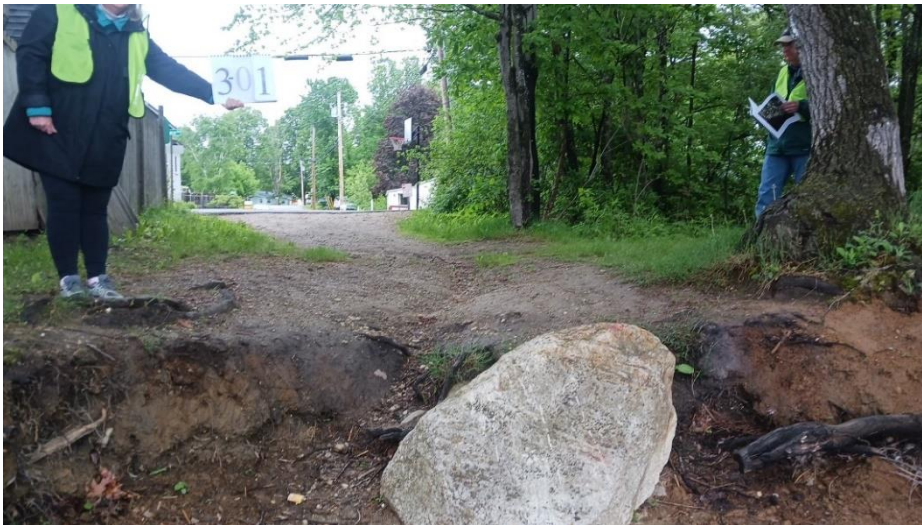
Figure 12: High-Impact Beach Access site

Road shoulder uphill from beach access is eroding and bringing runoff directly to pond. Survey team recommends installing runoff diverters, defining foot path, improve buffer and address ditching issue on uphill roadway.

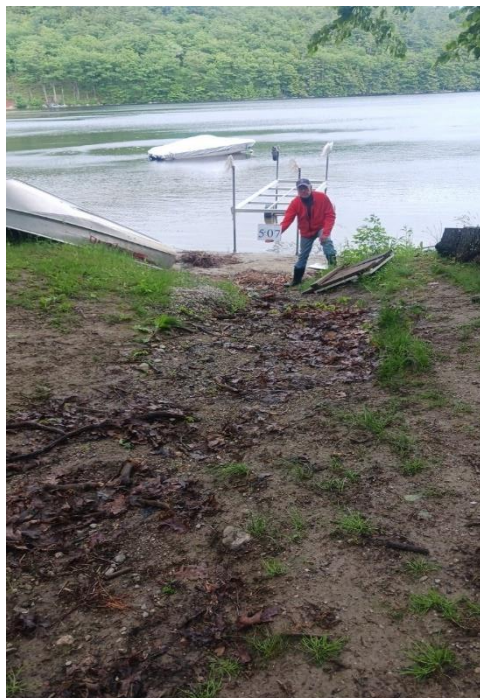
Figure 13: High-Impact Beach Access site

Culvert is being diverted directly to beach access area. Large amounts of sediment present all the way down to the pond. Survey team recommends rip rap and further assessment by technical staff or engineer.

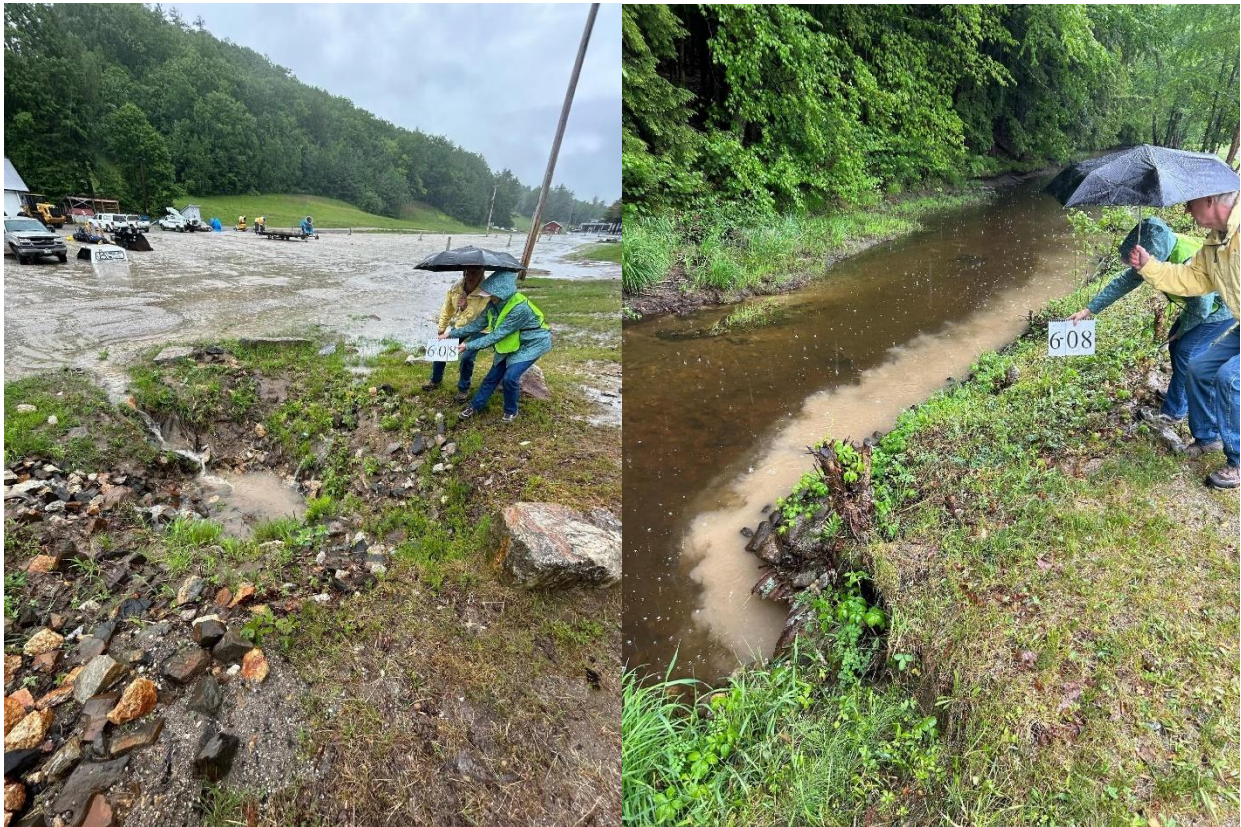
Figure 14 + 15: High Impact Commercial Site

Severe runoff from parking lot is depositing sediment directly into the stream. The problem is very visible during high flow events.

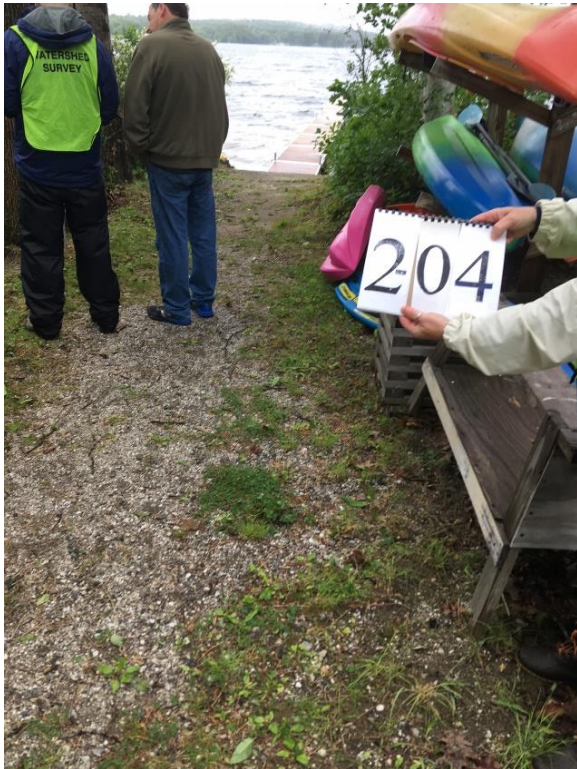
Figure 16: Low Impact Trail/Foot Paths Site

Surface erosion found leading directly to lake. Recommendation to cover with erosion control mulch, install runoff diverter and stabilize foot path.

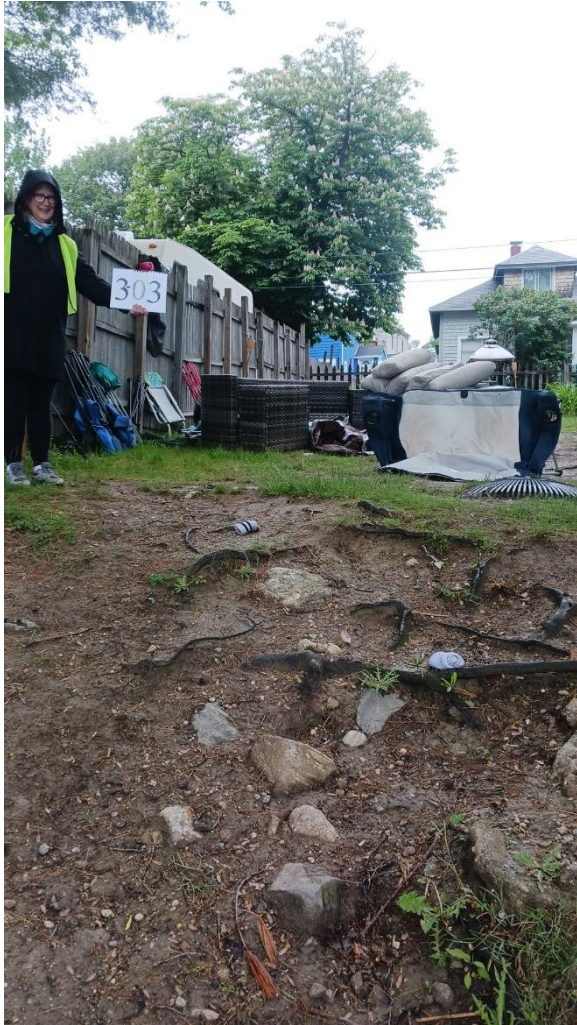
Figure 17: Low Impact Residential Site
Sheet Erosion leading directly to lake.

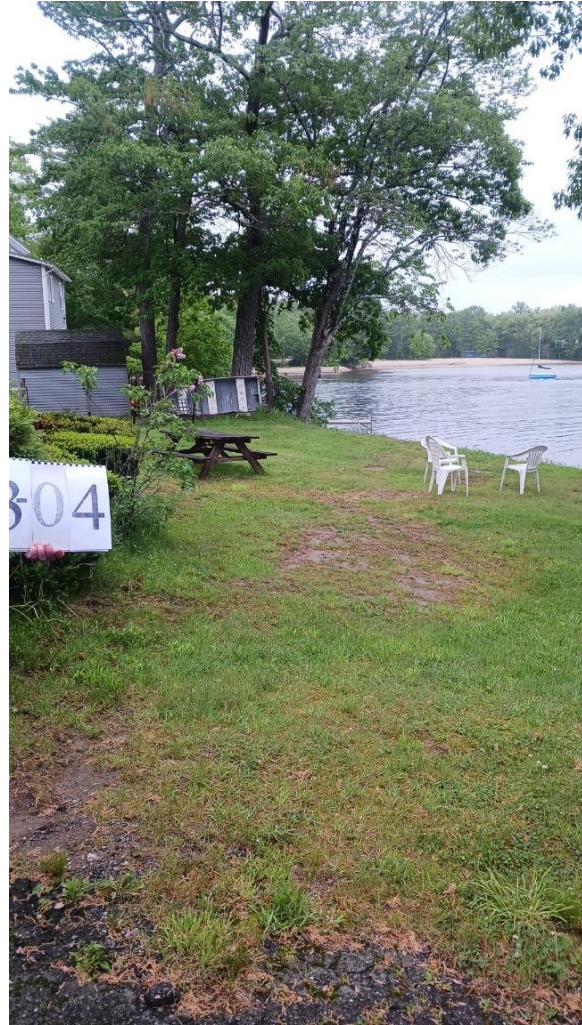
Figure 18: Low Impact Driveway Site
Sheet Erosion leading directly to lake.

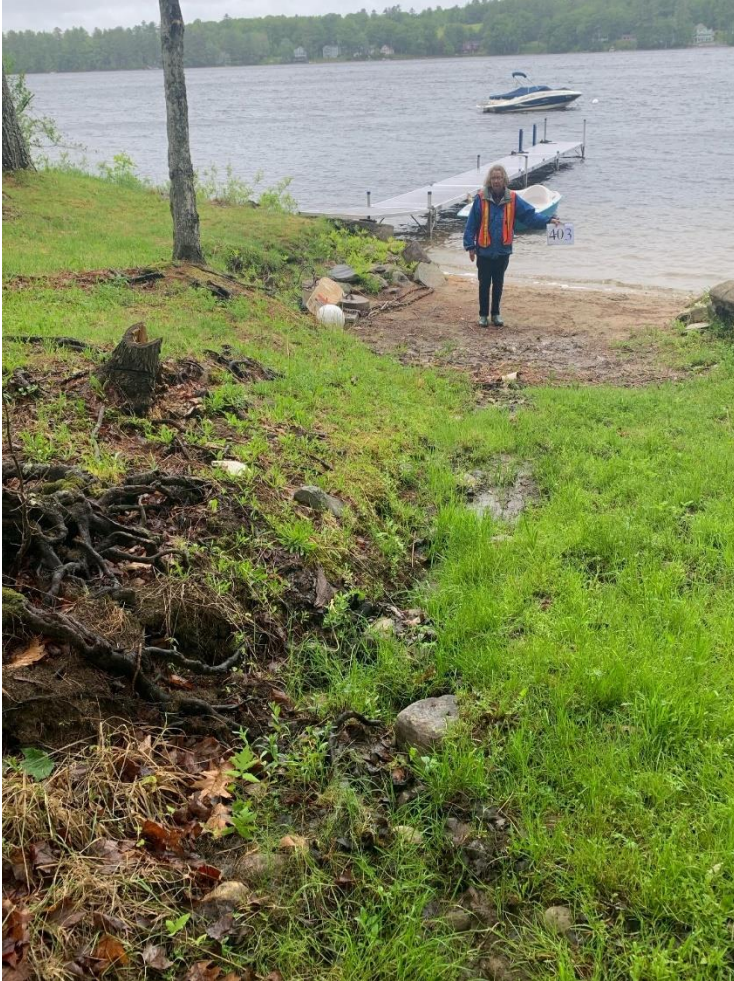
Figure 21: High Impact Private Road Site
Rill/Gully Erosion leading directly to lake.

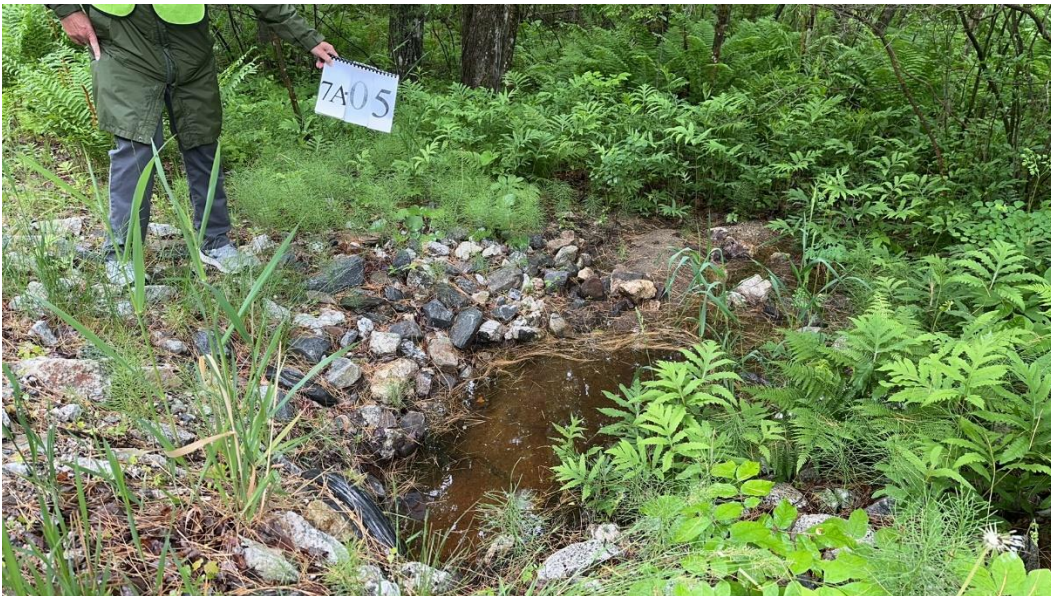
Figure 22: High Impact Town Road
Road shoulder erosion and sediment deposition directly into stream
